ITL RCR-7® | MINE TAILINGS POND, ARIZONA

PROJECT OVERVIEW

ITL RCR-7® was chosen to line the freshwater side of a tailings pond at a mine site in Arizona. A failing buried liner system along the face of the berm, which separates fresh water from dried tailings, was raising concern. Also of concern was the high-winds prevalent at the location contributing to erosion control issues.

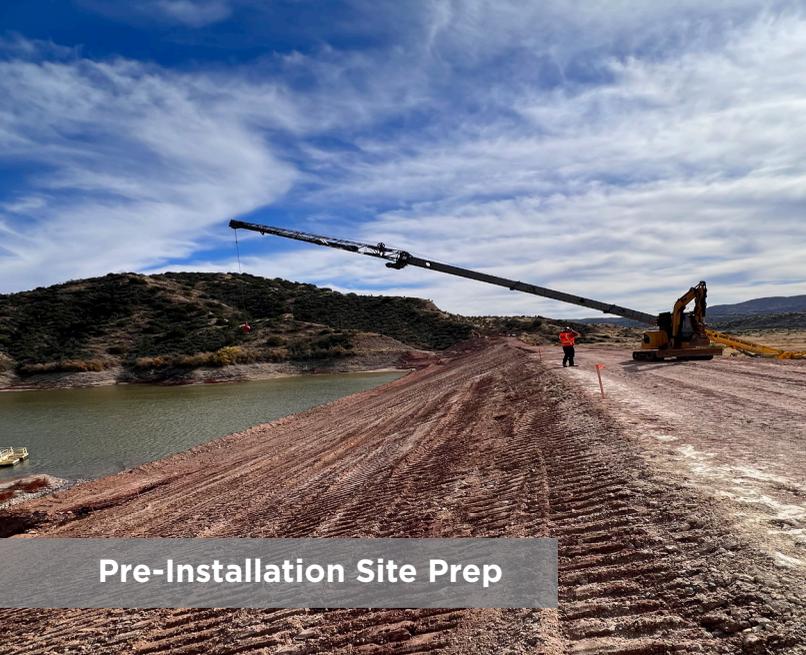
Pre-Installation Site Prep

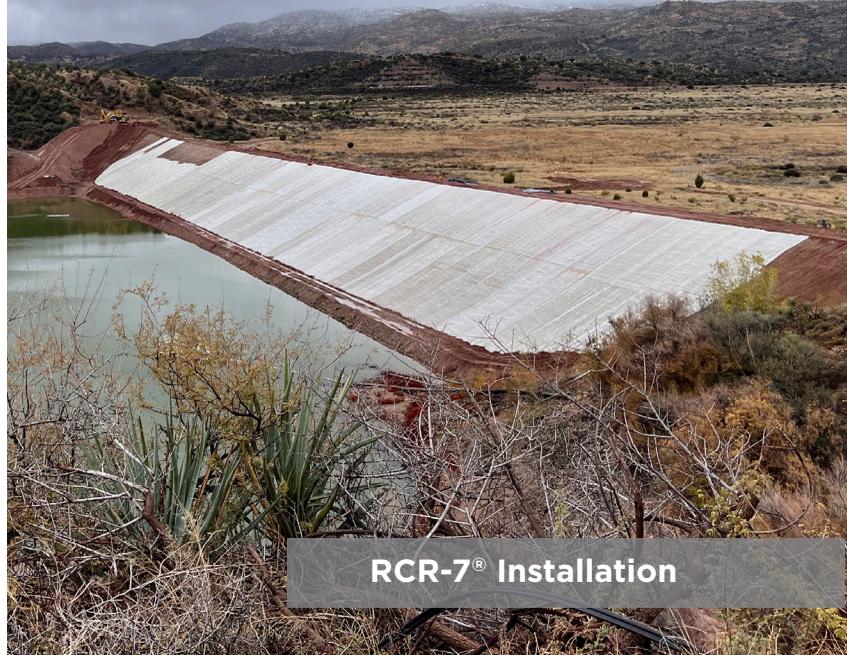
RCR-7® Installation

Over 120,000 ft² of RCR® was installed safely, rapidly and without any enhanced training or any specialty tools. The length of this slope was roughly 106 feet (32.3m) and angle approximately 2:1. Installation did require a crane and spotter as the crane lowered the product for unroll from behind the berm, on the dry tailings pond, nearly 20 vertical feet below the top of the berm.

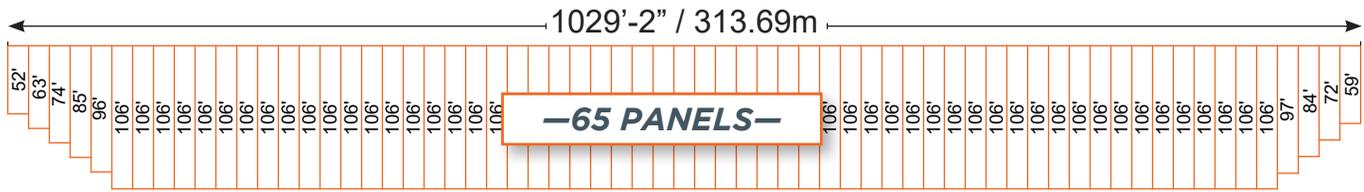
Illustration of pre-project panel planning.

Given the length of the slope of 106 feet (32.3m), and length of rolls ~65.4 feet (20m), roughly 1.6 rolls were required from the top anchor trench to the bottom anchor trench. The joint connecting the two rolls was created approximately one quarter of the way down the slope, overlapped ~1 foot (0.3m), with the top edge of the bottom RCR® being pinned in place using 6" long U-pins, spaced every 3 feet (1m). The anchor trench at the top was 2' deep and 2' wide, set back ~3'. The bottom anchor trench was 2' deep and 2' wide. The sides were also terminated using an anchor trench 2' deep and 2' wide.

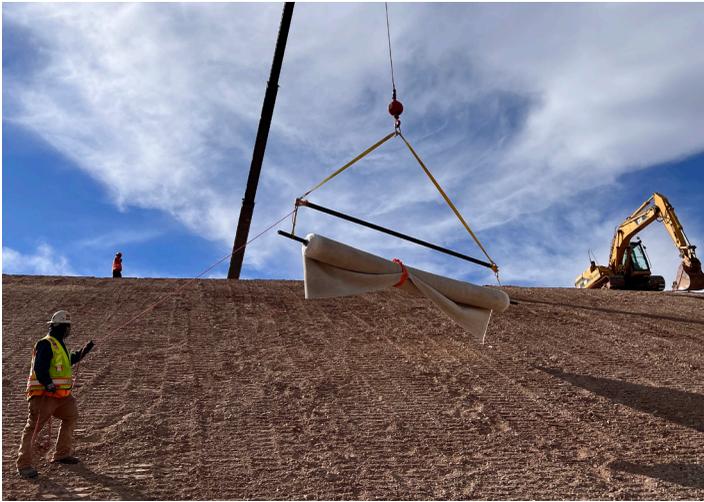
Crane behind berm, using spotter to place RCR® material.

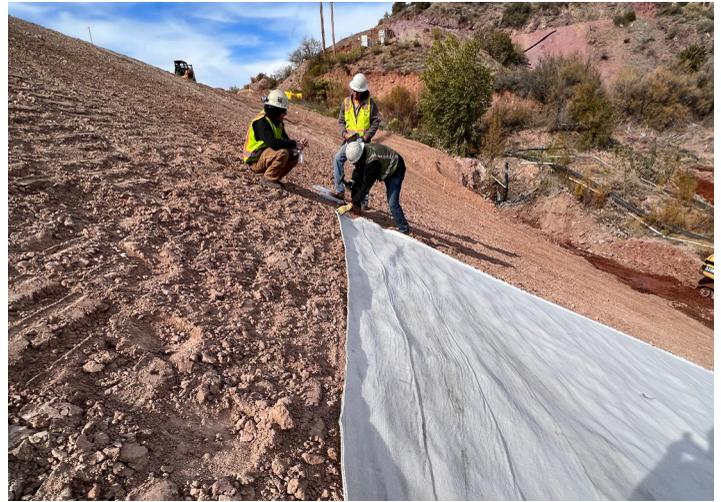
Slope angle made using this product a time and cost effective solution compared to traditional concrete.

Alternatives considered included a geomembrane liner and traditional concrete. Geomembrane was ruled out in favor of the customer's need for a more robust option that would also provide erosion control. This option was also bypassed for potential construction delays in this high wind area, as well as potential for repeated future repair. Traditional concrete was ruled out as a solution due to increased cost and difficult installation based on the slope angle and length.

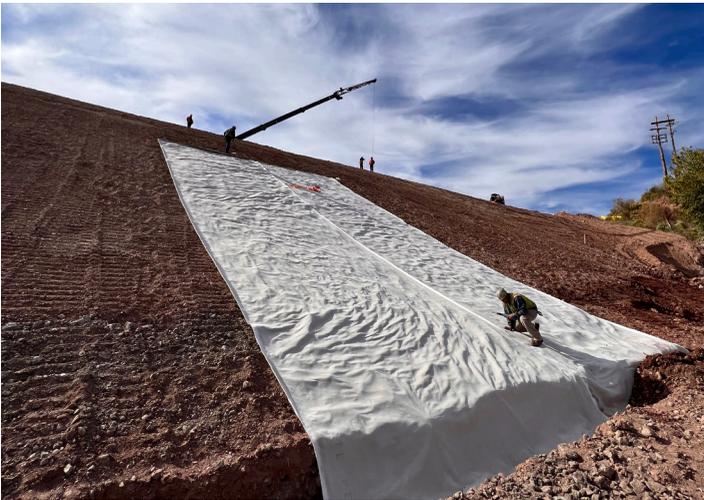
RCR® overlap and seaming. Bottom of berm anchor trench placement.

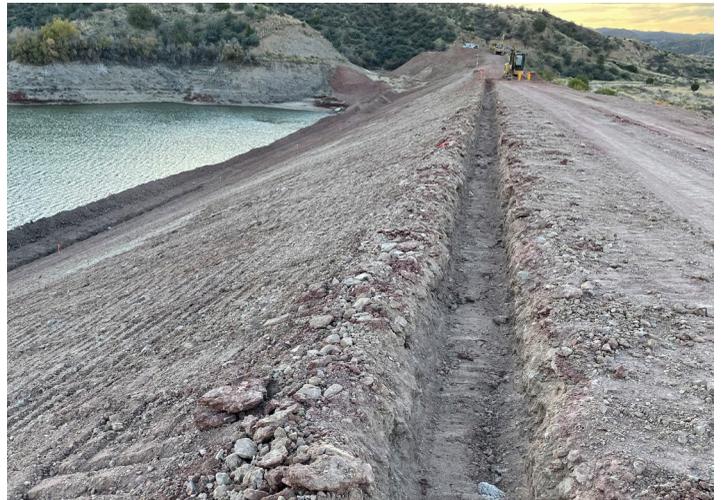
Site prep with top of berm anchor trench placement.
