PROJECT OVERVIEW

Hard Armoring an Aging Culvert

ITL RCR® | CULVERT APPLICATION, WYOMING

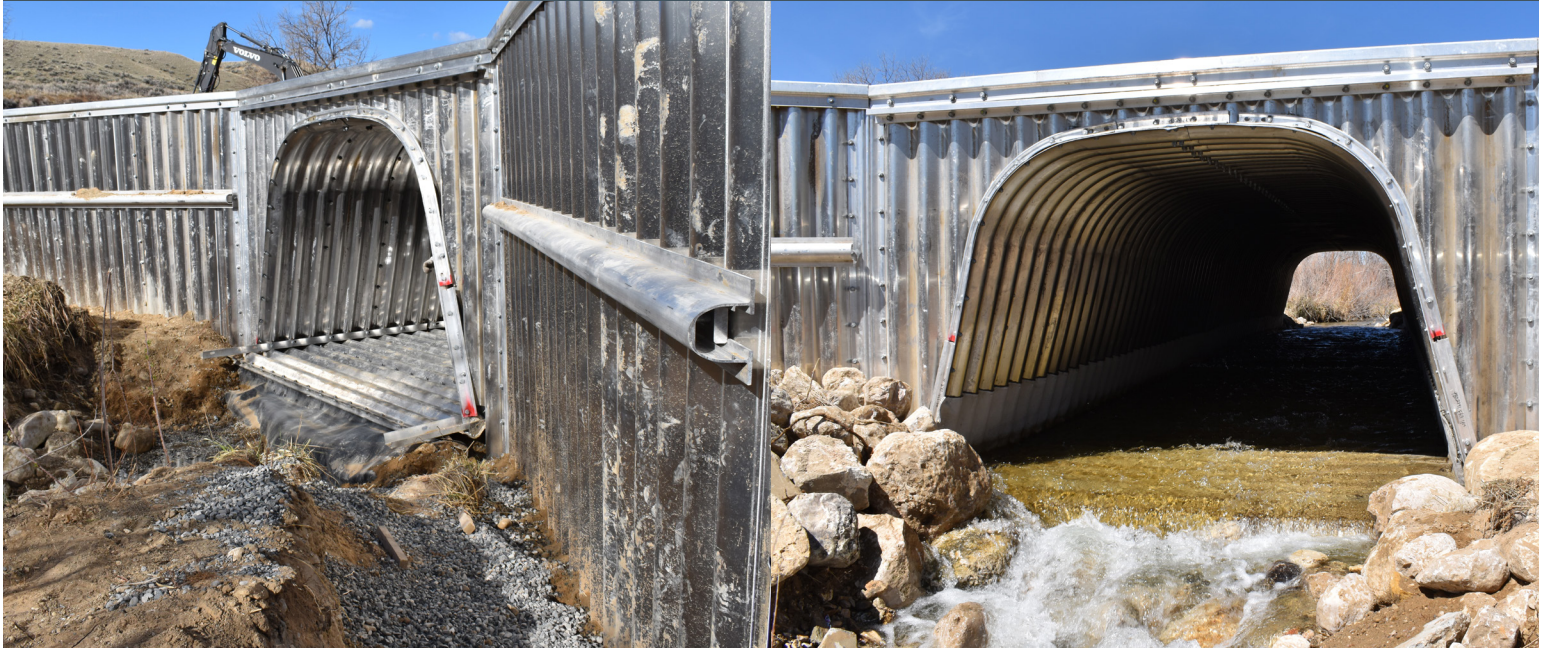
Cody, WY culvert before RCR® remediation

Cody, WY culvert after RCR® remediation during annual flush

RCR® was selected to create a hard armored liner along the culvert base. While RCR® is not used to provide structural support, the undermined cavity was first filled with polyurethane before the material was placed over the base to protect the culvert from further wear. Water testing results for RCR® are within EPA acceptable levels and do not pose significant health risks.

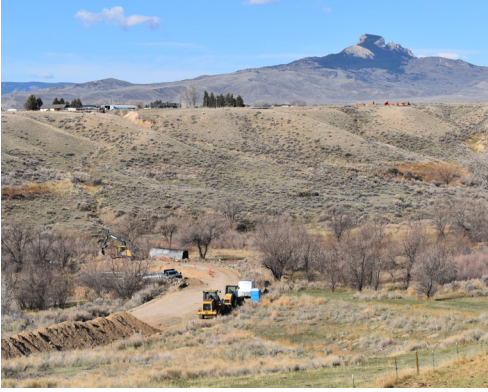
Remotely located culvert in Cody, WY

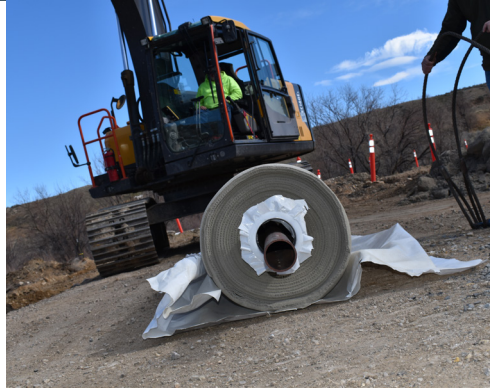
Unloading & prepping RCR®

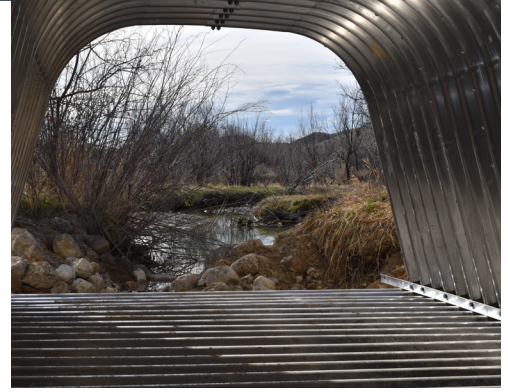
Engineering Associates and Park County were evaluating a multi-plate culvert that carried water beneath a county road. The invert plate section had significant corrosion, with areas where the metal had worn away and erosion had begun below the culvert. The roadway above served local transportation needs, while the culvert also carried a natural waterway supporting fish and wildlife habitat.

Culvert before remediation

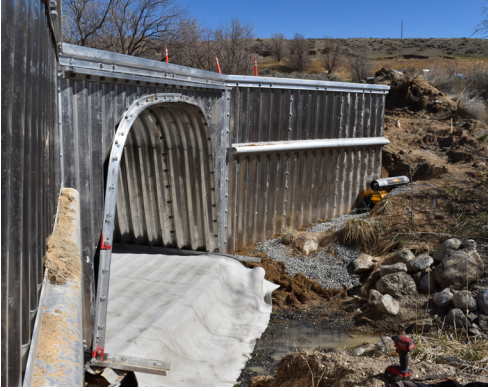
RCR lining outlet to fish run/wildlife habitat

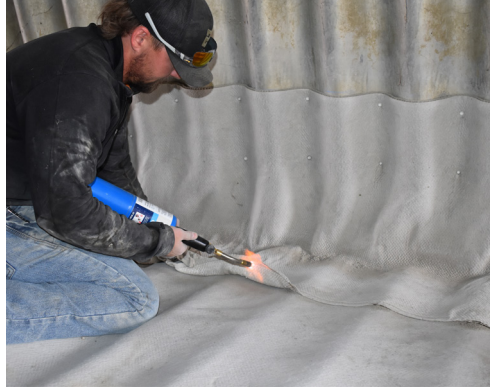
Heat welding RCR® seams

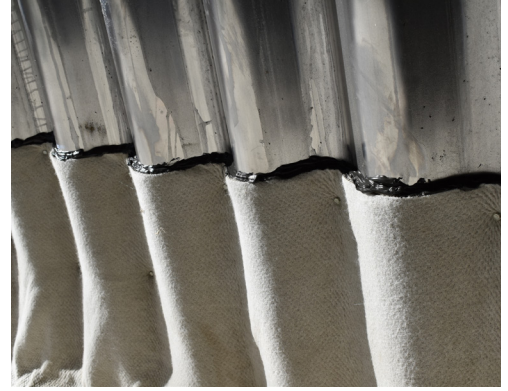
Wall panels secured and sealed

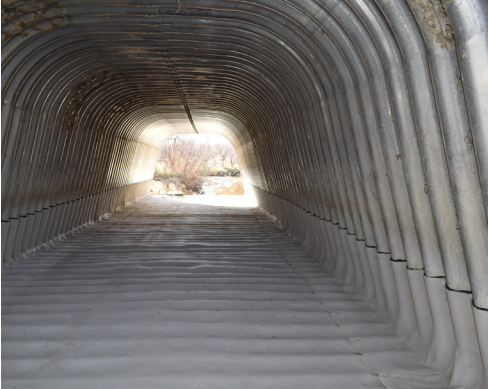
Completed installation-unhydrated

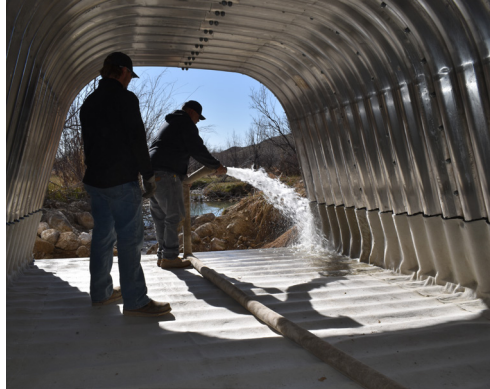
Hydration to cure

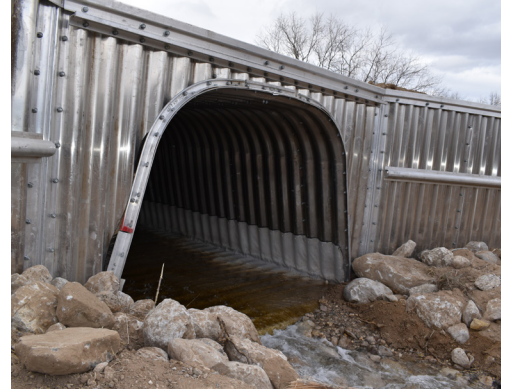
Addition of riprap to enhance erosion control

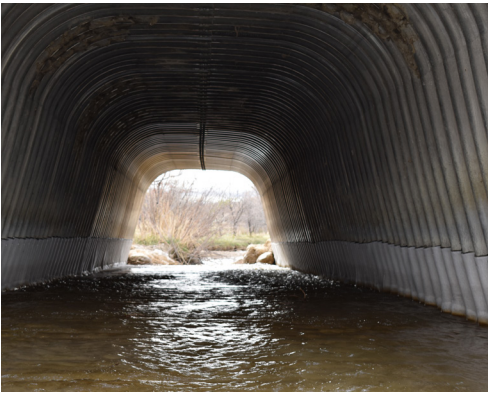
Waterflow in newly remediated culvert

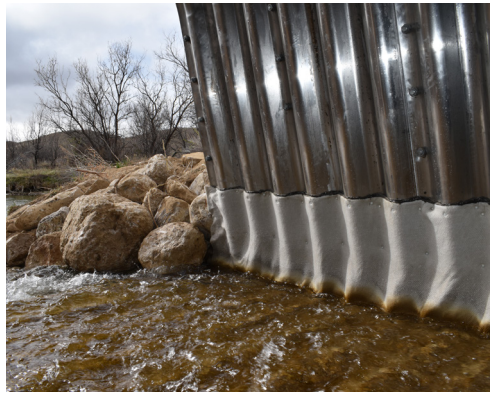
Closeup of RCR® and riprap working together

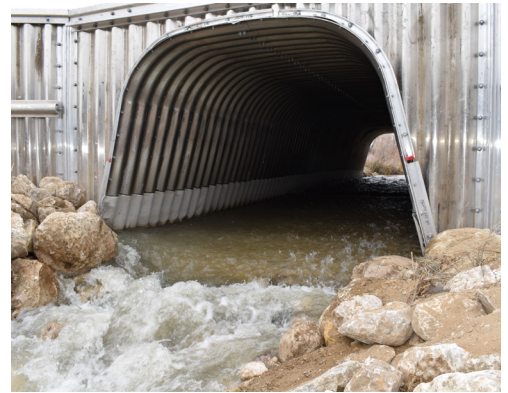
Annual flush after remediation

The installation was completed in two days by the county's own maintenance group, with no specialized tools or training required. Following installation, the material performed successfully through the 2026 irrigation flush, helping Park County protect the culvert, maintain the roadway crossing, and avoid the cost and disruption of full replacement.
