ITL RCR-7® | EROSION CONTROL MOUNTAINSIDE DITCH, CO

PROJECT OVERVIEW

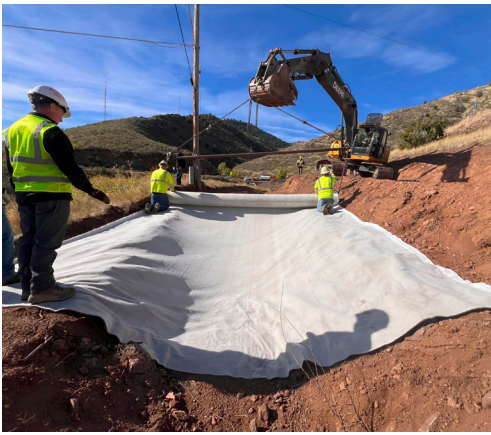
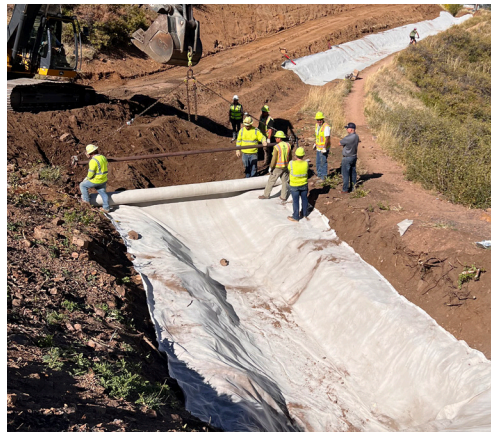
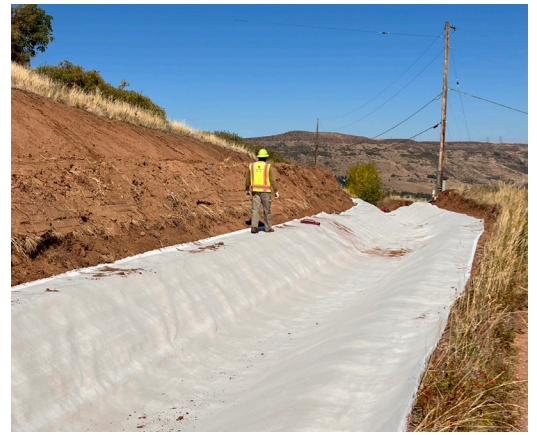
To address the erosion concerns, the RCR-7 reinforced concrete roll was selected for its effective erosion control properties and ease of installation. A temporary access road was carved on the uphill side of the stream, providing a staging area for the excavator. Using this access point, the excavator reformed the eroded stream bank and facilitated the precise installation of the RCR panels, each of which covered 65 feet of stream bank. County maintenance crews, despite having no prior experience with RCR, managed to complete the entire installation within a single day. Approximately 400 linear feet of the stream bank was armored, stabilizing the trail and stream bank without requiring extended closures or causing significant public disruption.
