# ITL RCR® | EROSION CONTROL TANK BATTERY PAD

## PROJECT OVERVIEW

At a tank battery site in Eddy County, New Mexico, hillside stormwater runoff had caused severe erosion and damaged part of the battery pad.

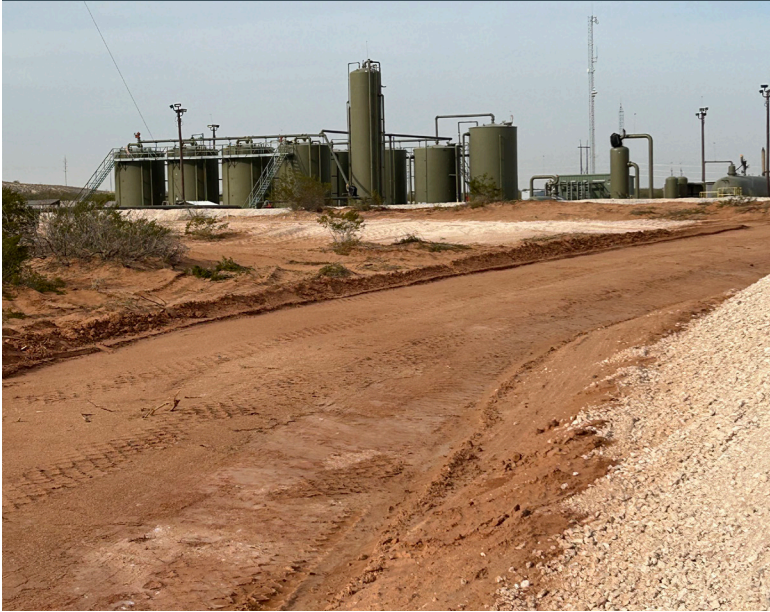
Ground work preparation prior to RCR® Installation

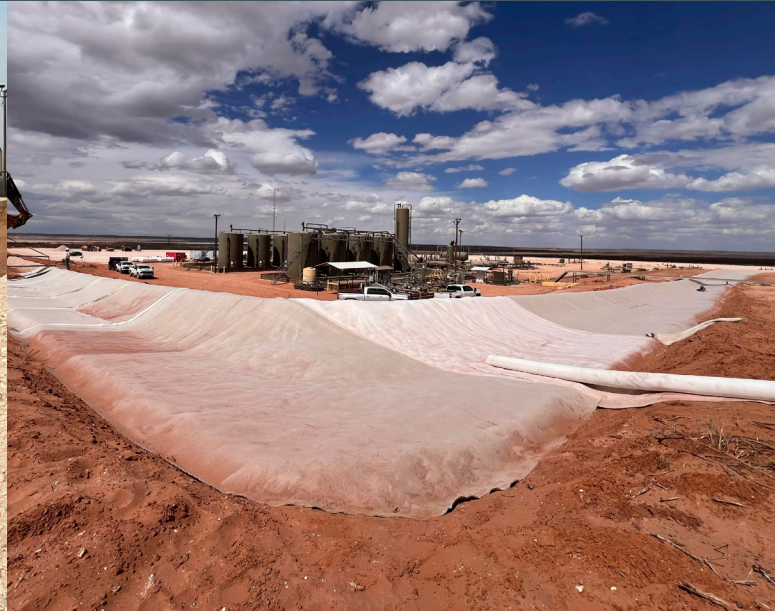
RCR® installation to redirect water runoff and prevent further erosion.

The tank batteries were located near the bottom of a hillside, where stormwater runoff had already caused major erosion and damaged part of the pad. To redirect future flows, a protective berm was built along the uphill side of the site using native material, with a swale placed above it to move water downhill around the pad.

Both the berm and swale needed a hard armor surface before monsoon season arrived. Rip rap and traditional concrete were considered, but the remote location made concrete logistics difficult and costly. ITL Reinforced Concrete Roll® was installed and hydrated in two days by a crew with no prior experience in RCR application. No specialized training or equipment was required.

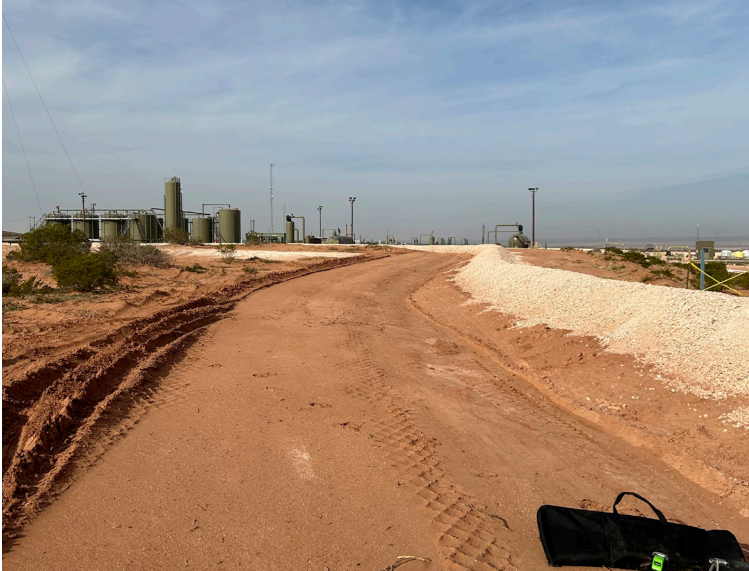
Compacted subgrade preparation prior to RCR® Installation

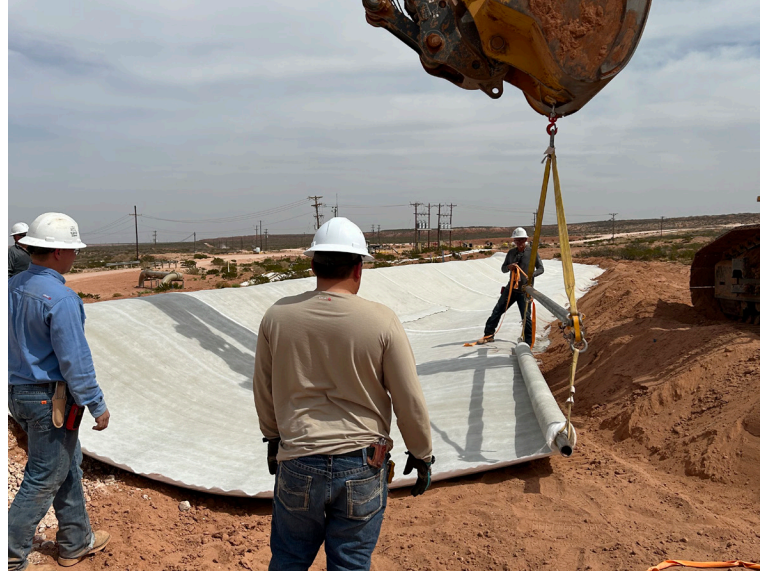
Installing RCR®

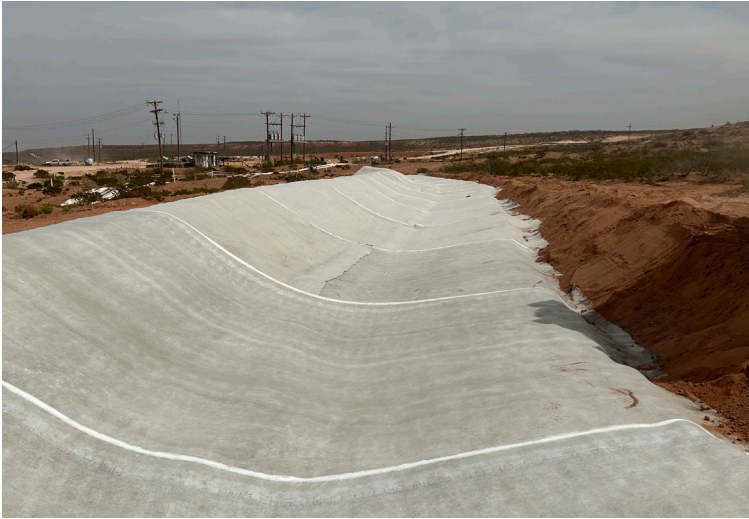
Close up of panel overlap

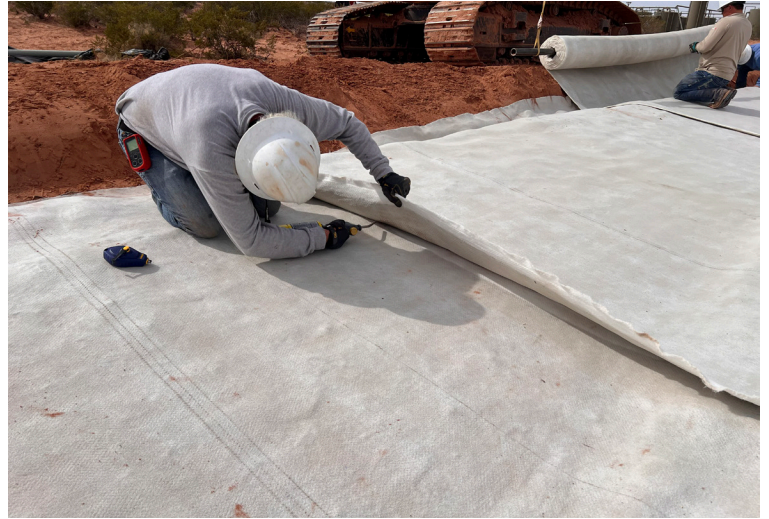
Seam welding with handheld heat torch

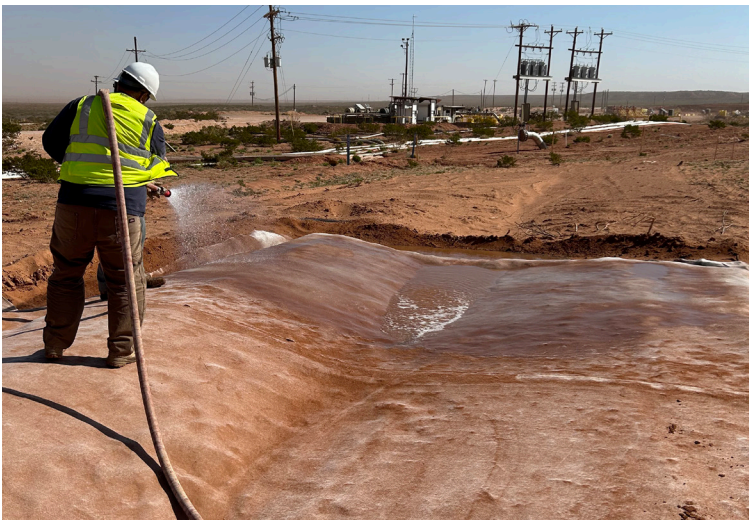
Hydration

Once hydrated, ITL RCR® formed a durable erosion control surface over the berm and swale. The material also allowed the crew to work around multiple pipe penetrations in the channel while preserving the intended flow path around the tank battery pad.

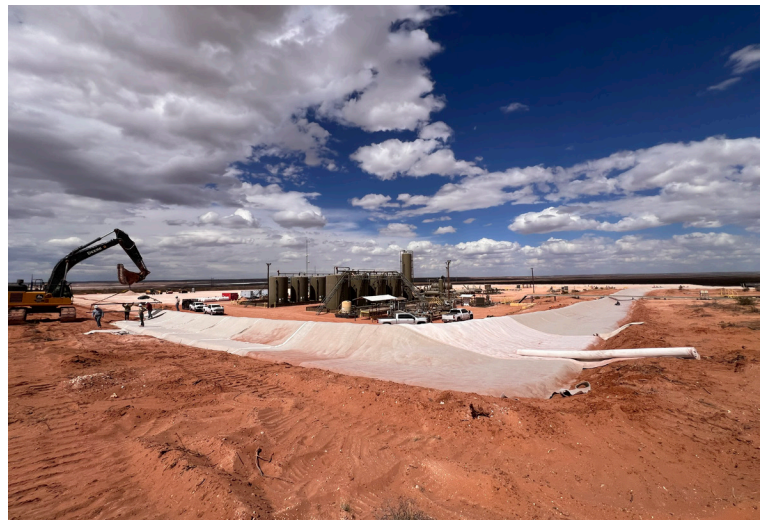
Scope of project to redirect runoff and prevent further erosion
